CASE STUDY

Packaging Failure: Discovery, Investigation & Resolution

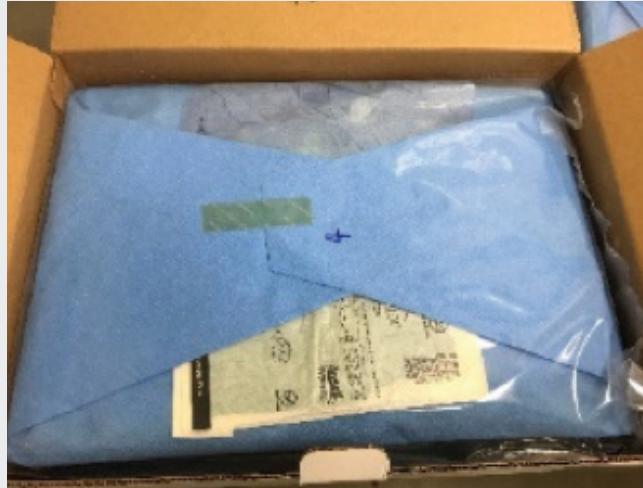
The product that came to the lab for testing was a surgical kit, wrapped in CSR wrap, with a header bag serving as the sterile barrier with five sterile barrier systems placed directly into a box. There were no cartons, dividers or other protection provided. This is a relatively large and bulky product packaging system with a nominal box weight of approximately 15 lbs.

View of sterile barriers inside the box

- Cutting away to view the contents within the shipper box showed that excess film from the taped header bag was getting bunched in the offending corner.
- The headspace of the shipping carton created an environment that allowed product to bounce around. This led to flex cracking.

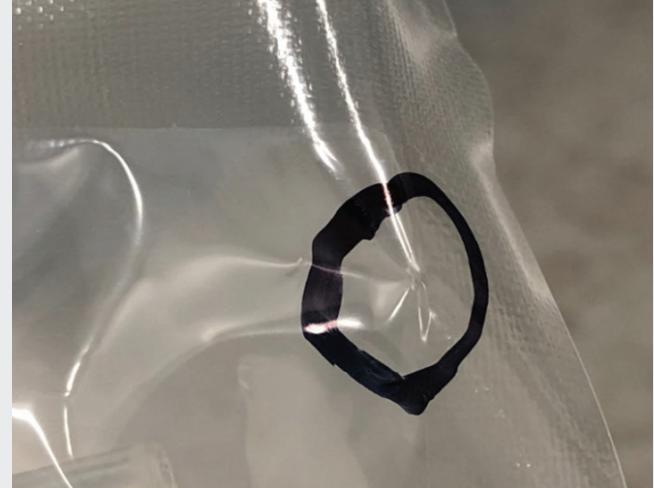
Initial integrity testing showed a high failure rate of approximately 50%, presenting as pinholes in the corners of the header bag. Time was of the essence to gain necessary approvals and meet project parameters.

Closeup view, example of pinholes in corner of bags

- The pinholes were consistent with one another—it was clear that we were dealing with one failure mode, not multiple failure modes.
- There were no obvious sources of puncture, whether from the outside in or the inside out.
- The bag material became “bunched up” in the corners of the bags when loaded into the box. In other words, there was excess or loose bag material with nowhere to go, making it crinkled and creased when the bags were loaded.

Redesign of Pouch

We eliminated the header bag and re-engineered a pouch. The new design used double layers of material to reinforce problematic areas by adding extra strips of Tyvek & film. In testing performance of 48/92-gauge polyester vs. 48/96-gauge, more pinholes occurred in the thicker 48/92 version. We also tested and ultimately selected a nylon pouch. Nylon typically demonstrates better flex resistance than polyester. The new packaging system allowed the client to get back on track without packaging fails, ensuring sterility of the surgical kit to the end use.
